Subject review / Pregledni rad

NEGLECTED MARINE STRUCTURES – THE MIAMI MARINE STADIUM vs. THE RIJEKA TORPEDO LAUNCH PAD STATION

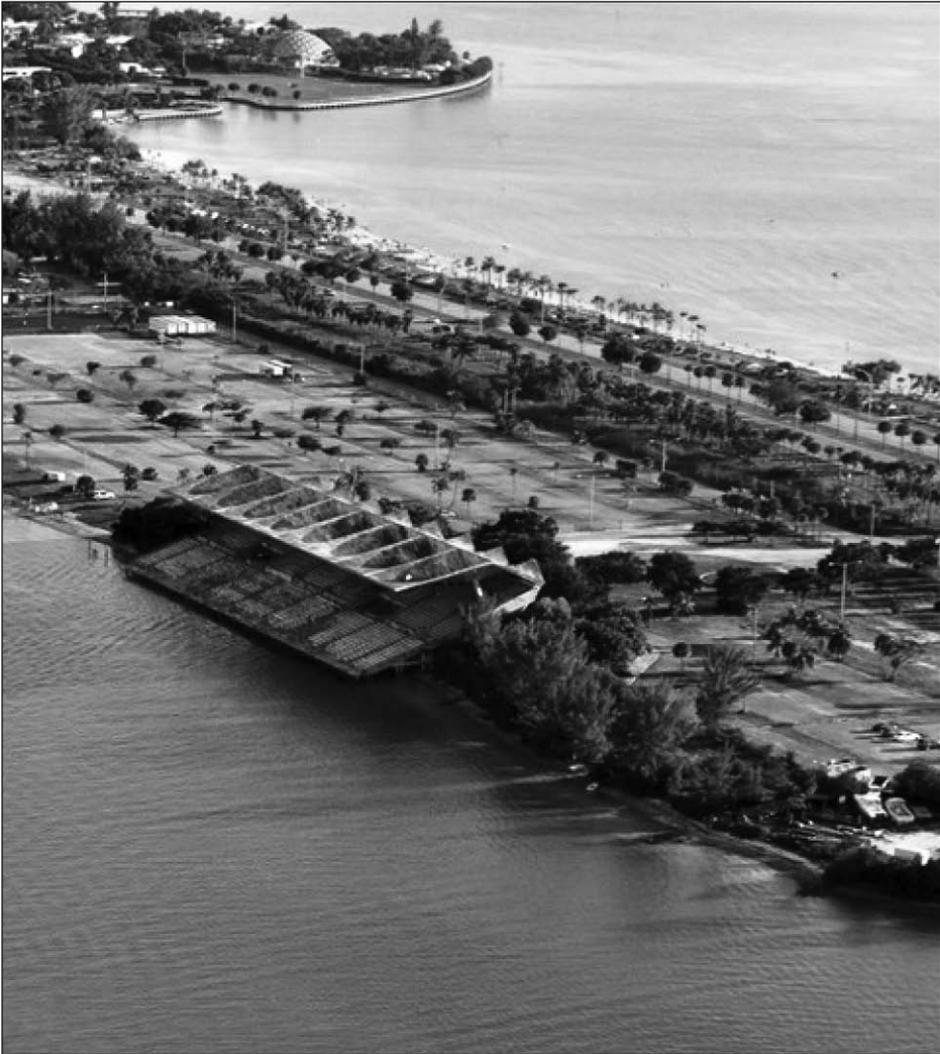
■ **Figure 2** *The Miami Marine Stadium – aerial view (photo courtesy of Friends of Marine Stadium)*

Built in 1963, Commodore Ralph Middleton Munroe Miami Marine Stadium (Miami Marine Stadium) was the first purpose-built venue for powerboat racing in the United States (World Monuments Fund, 2009). The signature element of architect Hilario Candela's design is the stadium's concrete hyperbolic paraboloid roof with 20 m long cantilever (Figure 2). Such element places Miami Marine Stadium among buildings with one of the longest nontruss cantilever roof spans in the world. Another unusual feature of the design is that about one-third of the Stadium is built over the water on concrete piers. This 1960s concrete structure became the modernist landmark on the Miami, FL, waterfront.

The Stadium is a cast-in-place concrete structure consisting of five primary structural systems (Brainerd, Tumialan and Bronski, 2011):

- Foundations: concrete piles with pile caps supporting columns, grade beams, and a seawall;
- Ground-level structure: grade beams and structural slabs-on-ground;
- Mezzanine-level structure: slabs and pan joists generally supported by beams and columns but in some cases supported by hangers connected to the grandstand structure;
- Grandstand structure: vomitory and parapet walls, raker beams, tie beams, and columns supporting tread-and-riser seating slabs; and

- Roof structure: eight hyperbolic paraboloid (hypar) shell units joined by a longitudinal post-tensioned diaphragm wall-each hypar shell unit comprises four hypar shells and is supported by three inclined columns – two at the back and one in the interior.

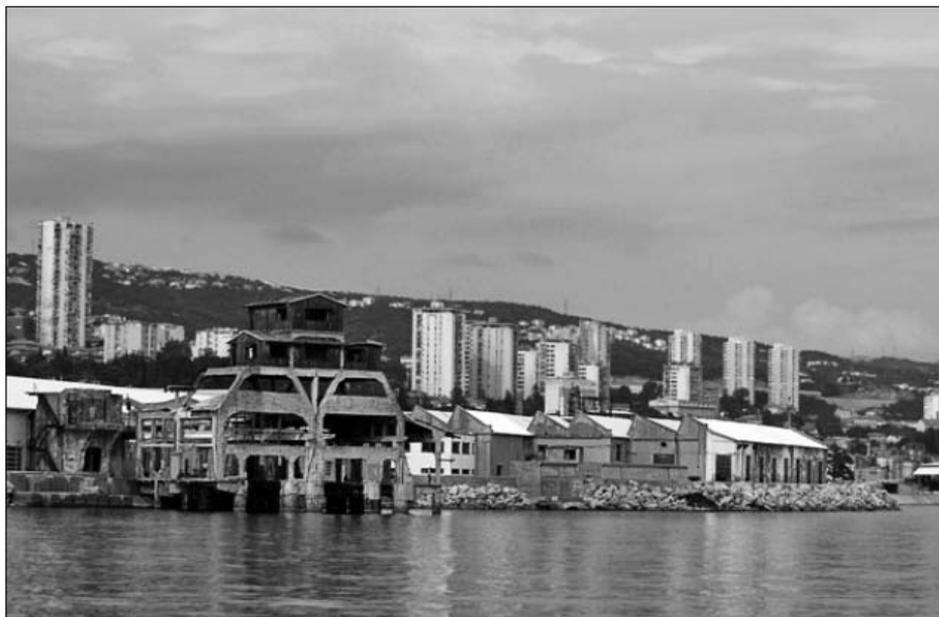
■ *Figure 3 Torpedo Launch Pad Station and former Torpedo factory (photo courtesy of Ivan Marović)*

Torpedo launch pad station in Rijeka, in shape as we know it today, enabled simulation of all mentioned torpedo launch positions (Figures 3 and 4), and was constructed in two phases. First phase started at 1929 when the eastern part of the facility was built, and the second one constructed in the period from 1936 till 1945 when the western part of the facility was built.

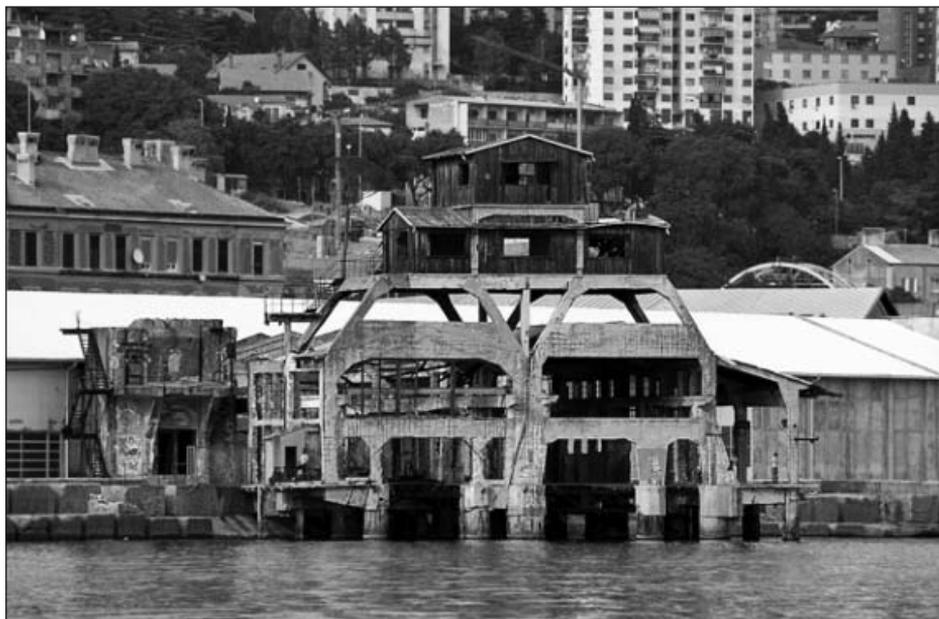
■ *Figure 4 Front view of Torpedo Launch Pad Station (photo courtesy of Ivan Marović)*

Building of launch pad station was made of reinforced concrete, steel, stone, wood and glass. Whole bearing structure was made of reinforced concrete and steel, while wall fillings and façade walls were made of stone blocks and hollow bricks with vertical cavities in combination with glass. Roof structure was made of wood. On the south side of the roof structure, wooden observation post was constructed, and was enhanced in relation to remaining roof structure. Facility was founded in very specific conditions; partly on shore and partly on piles and piers in the sea. Most part of the facility, around three quarters, lies just above the sea level where the average depth is ten meters.
